Ball Valve Dismantling.

**3" FULL BORE
BALL VALVE**

Ball Valve Re-assembly.

**3" FULL BORE
BLACKO BALL VALVE**

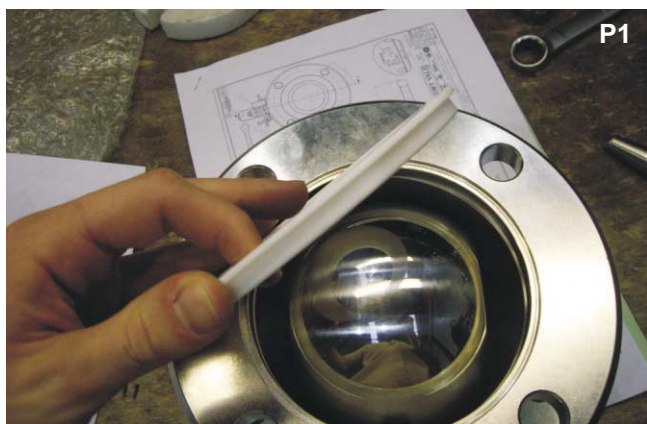
Remove the front seal from valve body.

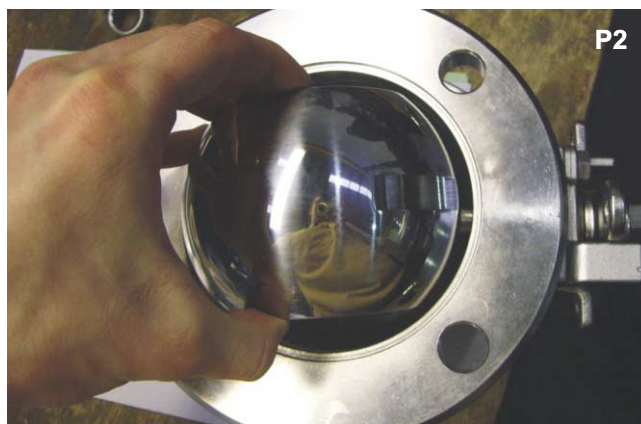
Using the ball valve handle, rotate the ball until the slot is inline with the axis of the valve. This will allow the ball to be carefully removed from the valve body.

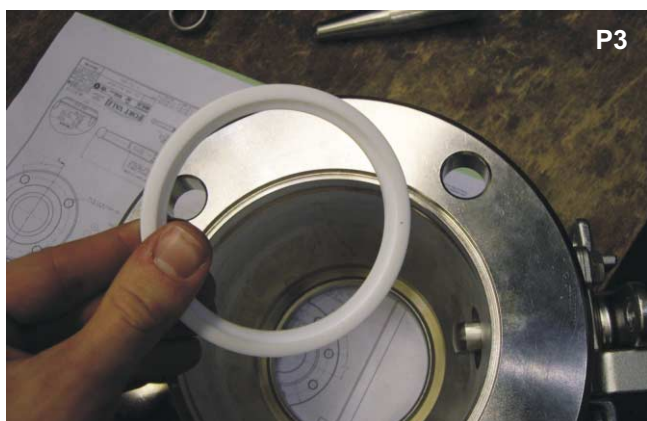
Remove the bottom ball seal from the valve body.

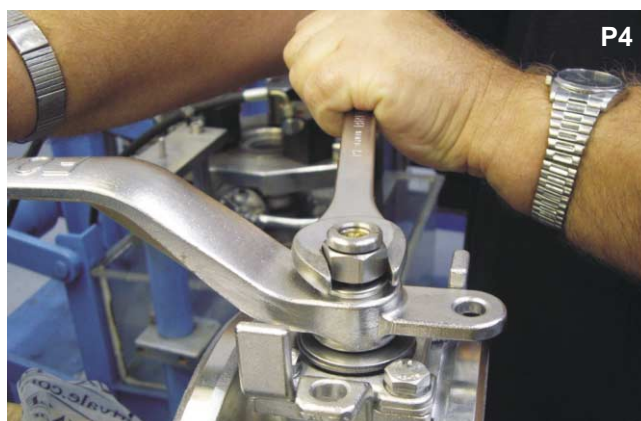
Holding the valve handle and using a 19mm remove the M12 lock nut.

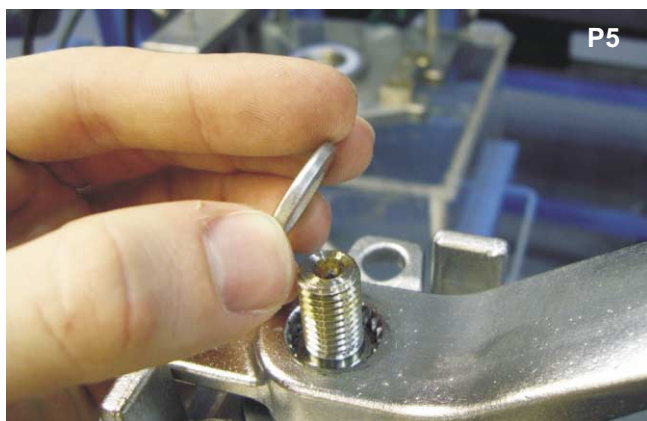
Remove the M12 washer.

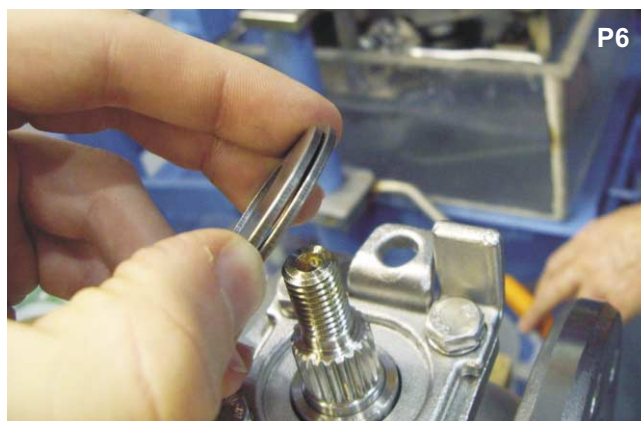
Remove the two Belleville washers noting the orientation.

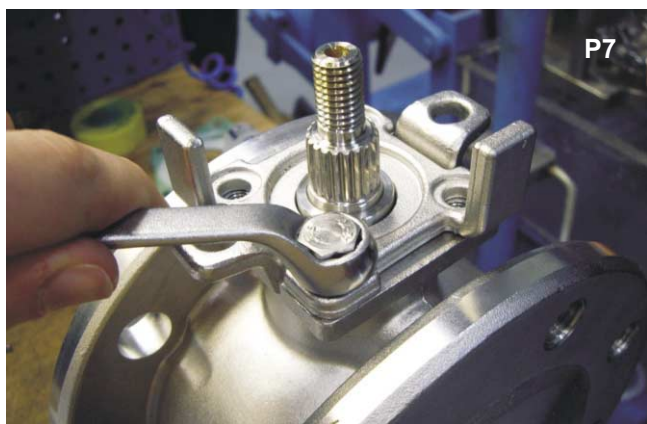
Remove the four M8 bolts securing the stuffing clamp in place.

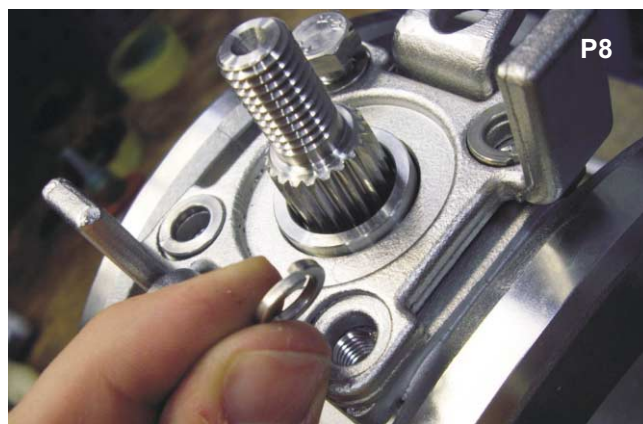
Remove the four M8 spring washers.

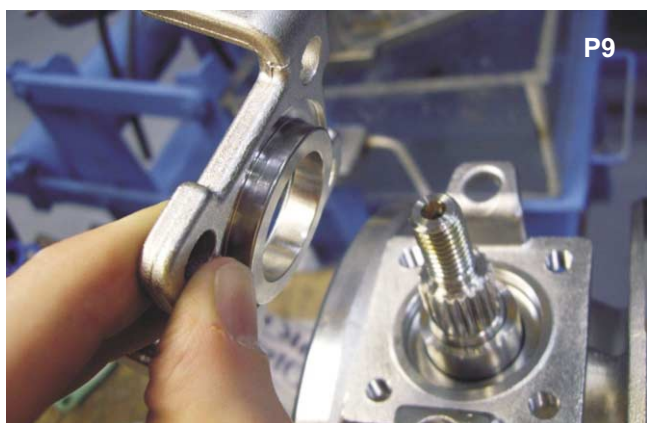
Remove the stuffing clamp.

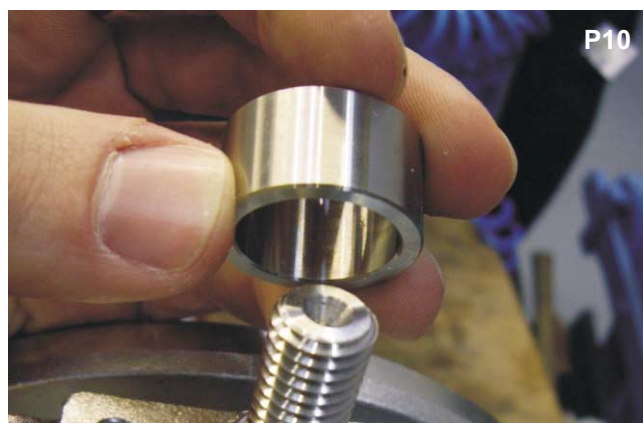
Remove the top stuffing bush.

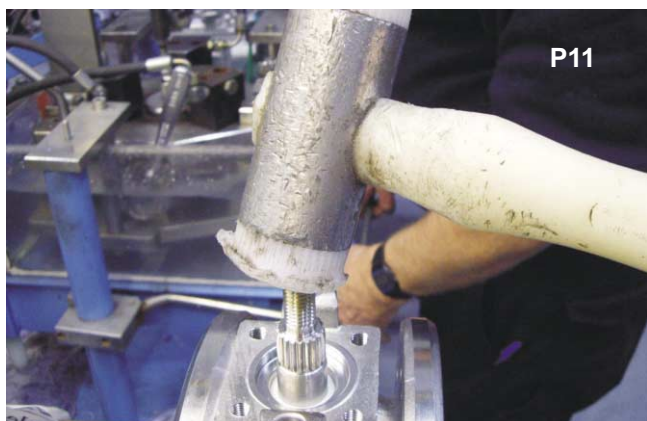
Gently tap the spindle to free from bore.

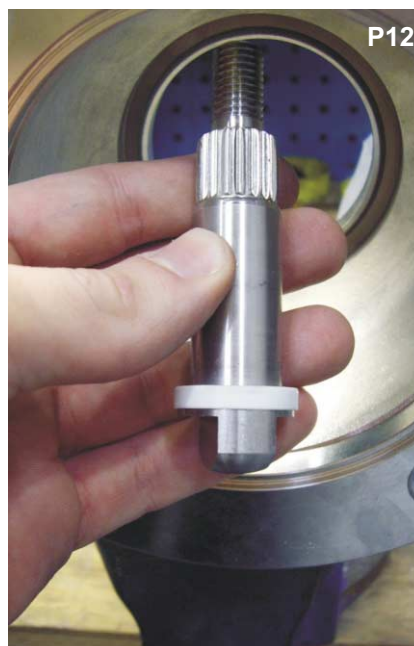
Once free from bore remove the spindle from the valve body.

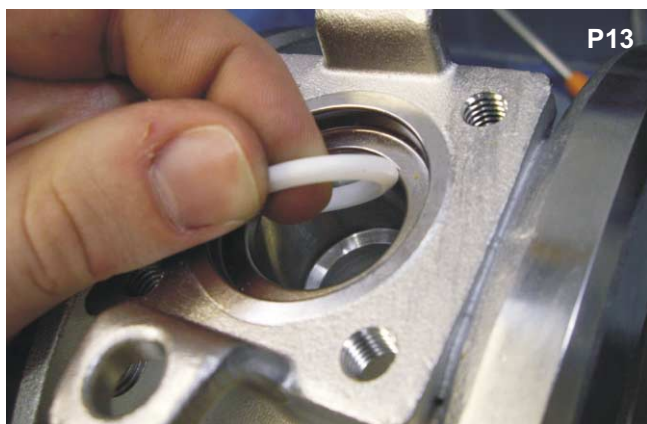
Once the spindle has been removed, remove the remaining stuffing collar and PTFE 'o' rings. Ensure no marks are left in the spindle bore.

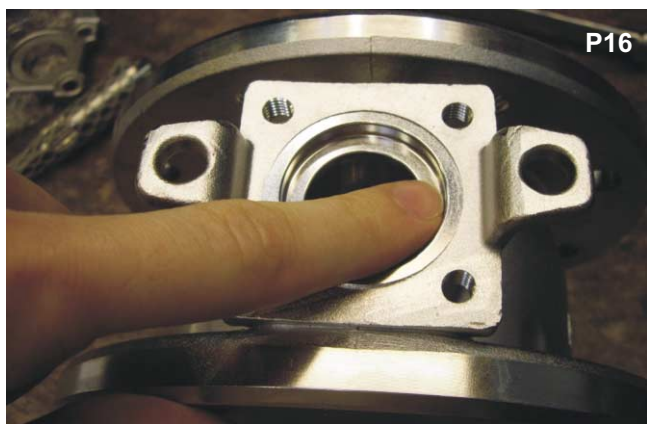
Examine the spindle housing for damage both in the top and bottom bore.

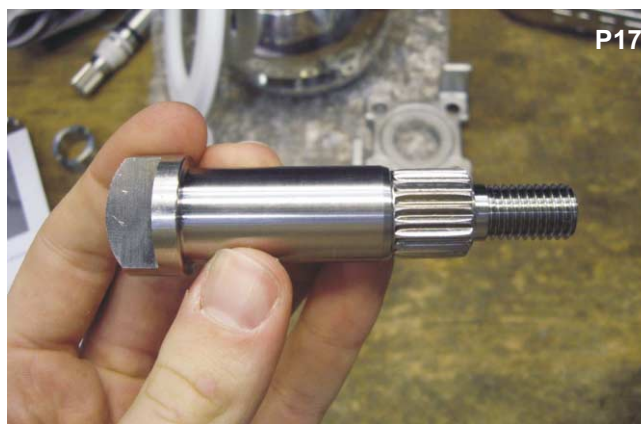
Examine the valve spindle for damage along the diameter where the seal will be located.

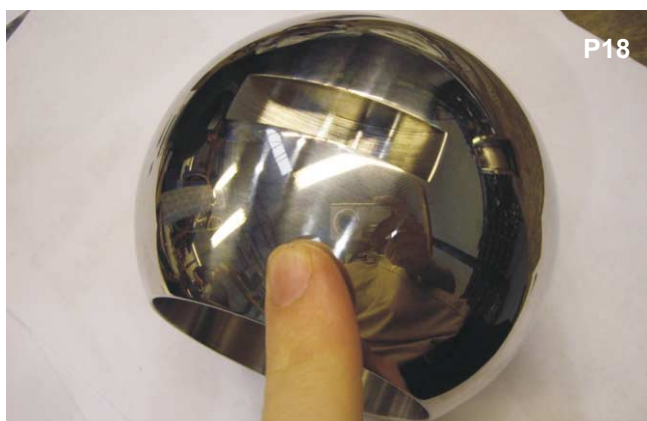
Check the ball for excessive wear, scratching or damage around the sealing areas at both ends of the ball.

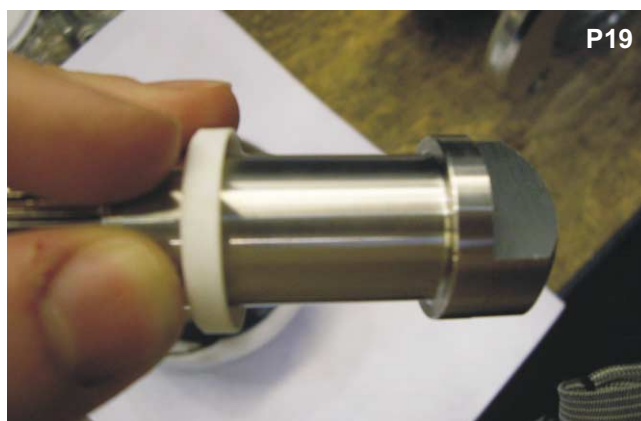
Slide the bottom bearing over the valve spindle with the recess over the head of the spindle.

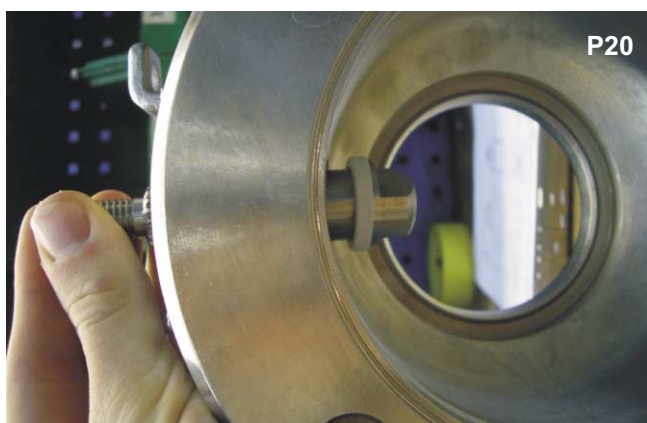
Insert the spindle into the housing from the inside of the valve body.

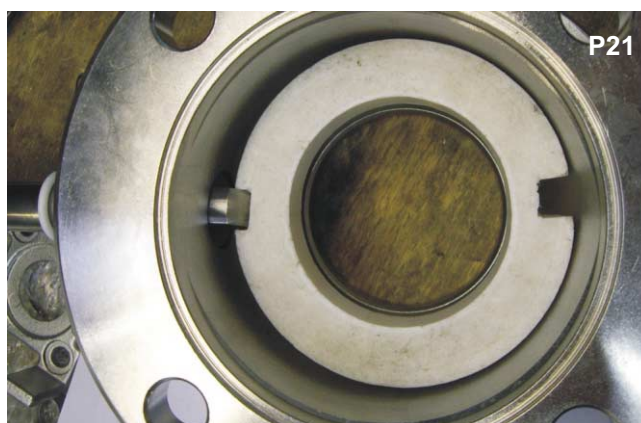
A tool like the one shown above (which is simply a 4.5" diameter piece of PTFE bar with a cut out for the spindle to locate on) must now be used to stop the spindle falling out.

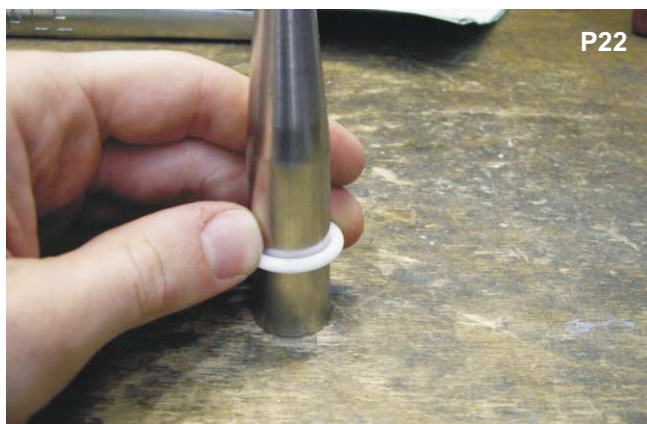
Push the PTFE 'o' ring over the 'o' ring expander tool, which can be purchased from Fort Vale. Keep the 'o' ring on the biggest diameter.

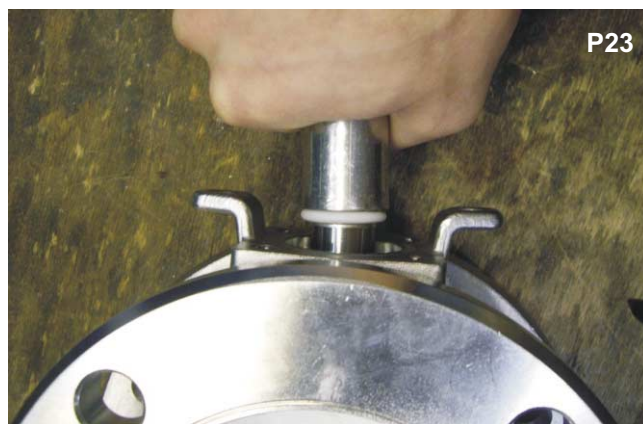
Put the expanding tool over the spindle and push the 'o' ring down until it can move no further. This will require a separate seal pusher to fit over the 'o' ring expanding tool.

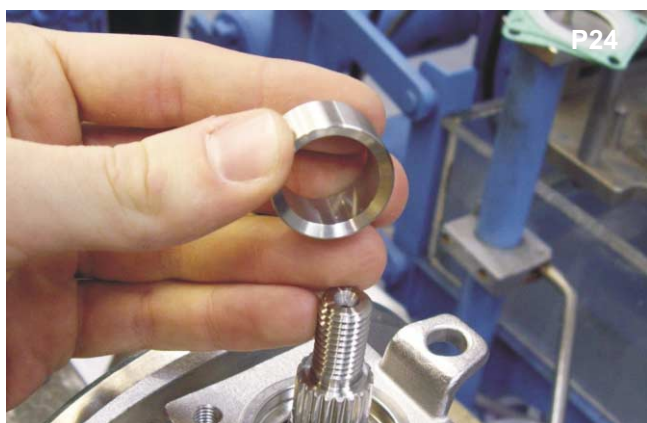
Ensure the correct orientation when inserting the stuffing collar. The bevelled edge must locate on the PTFE o ring.

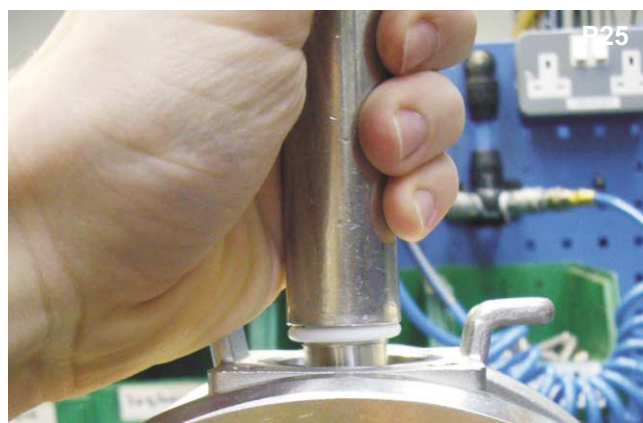
Insert the second PTFE 'o' ring again using the expanding tool

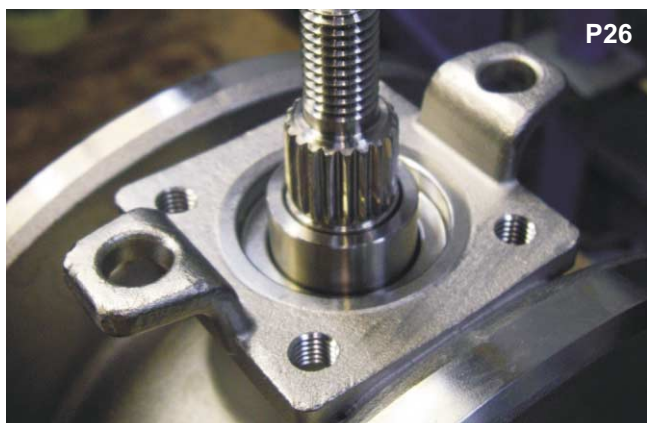
Replace the top stuffing collar.

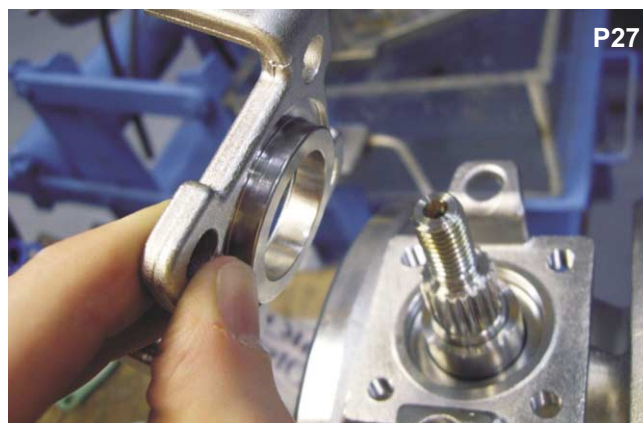
Replace the clamp plate, the orientation of the clamp plate determines on which handing is required.

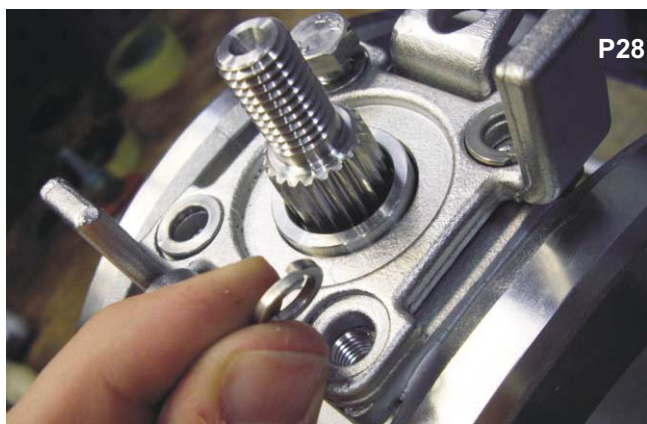
Replace the four M8 spring washers.

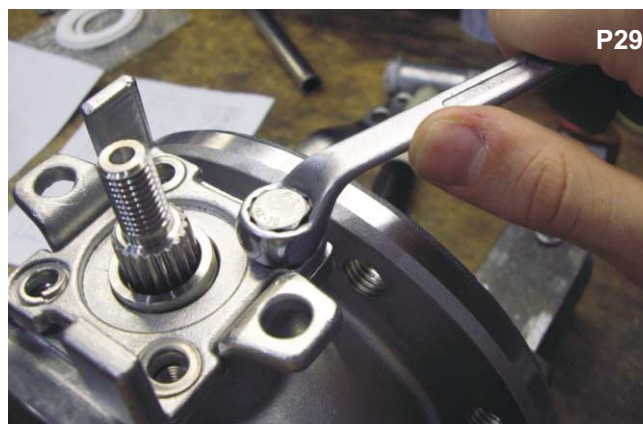
Using a 13mm wrench hand tighten the clamp plate bolts.

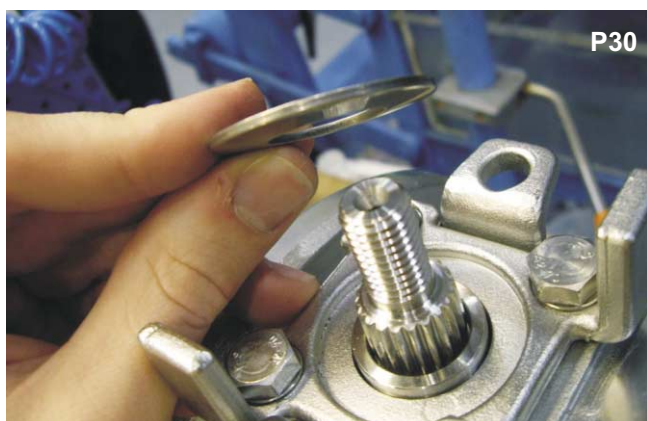
Replace the first Belleville washer, this must be placed dished side down as shown.

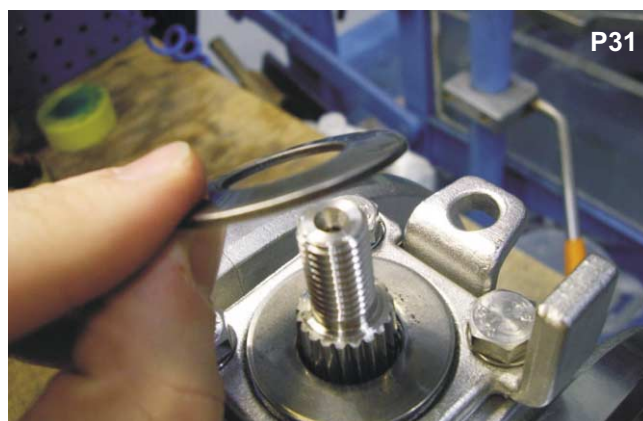
Replace the second Belleville washer dished side up as shown.

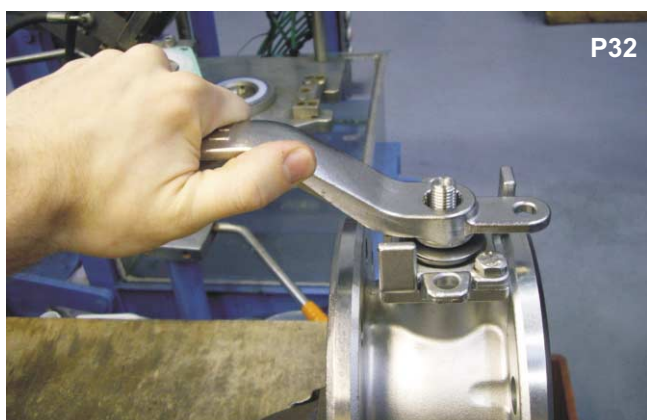
Replace the valve handle, ensuring the orientation of the spindle and handle. With the handle in the closed position the flats of the spindle should be in line with the body axis.

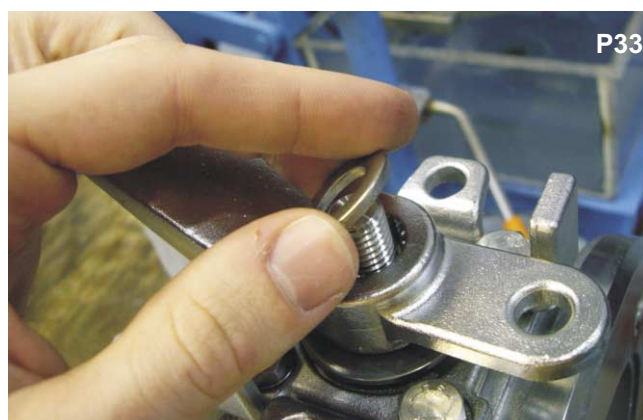
Replace the M12 washer.

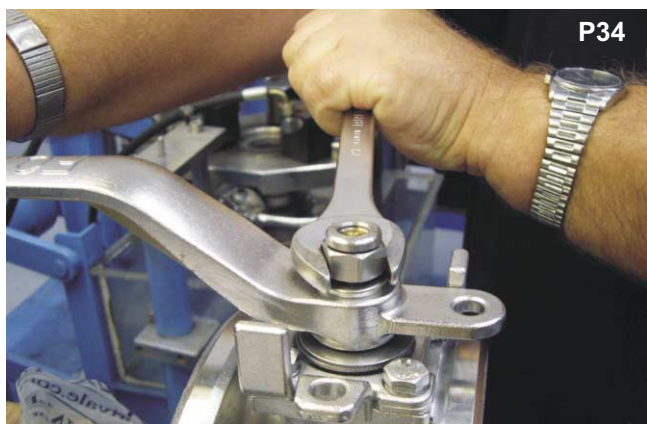
Holding the valve handle tighten up the M12 nut using a 19mm A/F wrench.

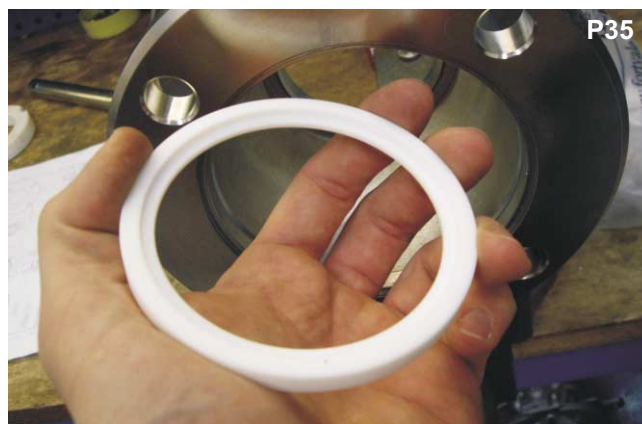
Ensure the back seal is in the correct orientation. Inspect the valve body for any dirt and foreign objects.

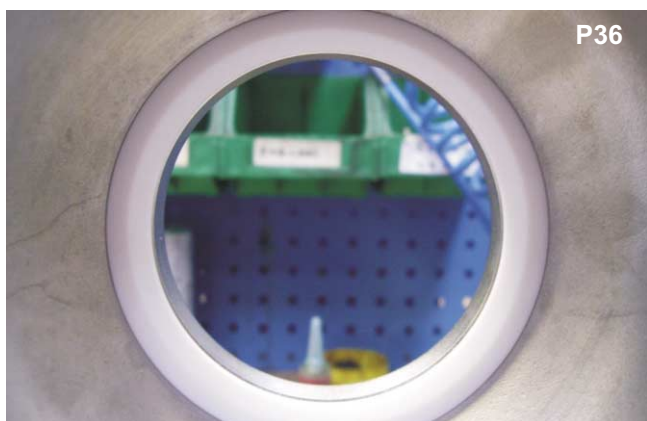
Ensure the back seal is fully located in the back groove.

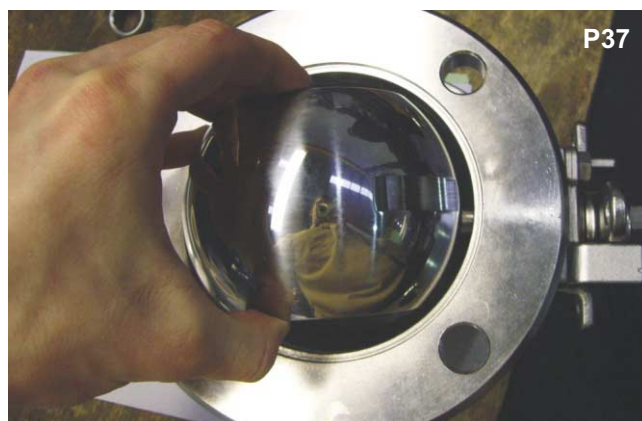
Roll the ball into the valve body.

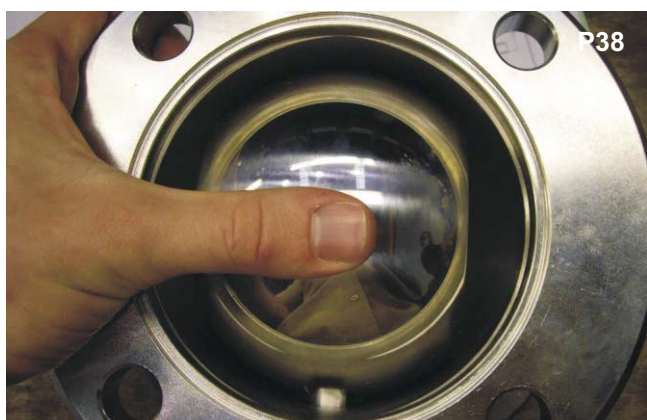
Slight adjustment of the stuffing clamp may be required to ensure the ball is correctly aligned in the valve body and seats. Once adjusted fully tighten up the clamp plate bolts which had previously been hand tightened using a 13mm A/F wrench.

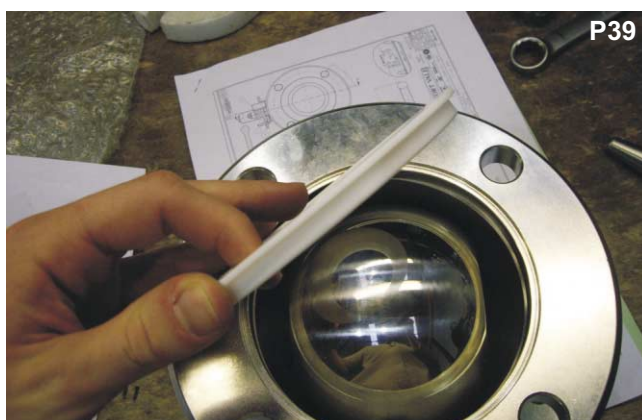
Replace the front ball seal.
